PORT OF PORTLAND TERMINAL 5 STRUCTURAL REHABILITATION AND CORROSION PROTECTION

BY STEVE GEIGER

Port of Portland Terminal 5

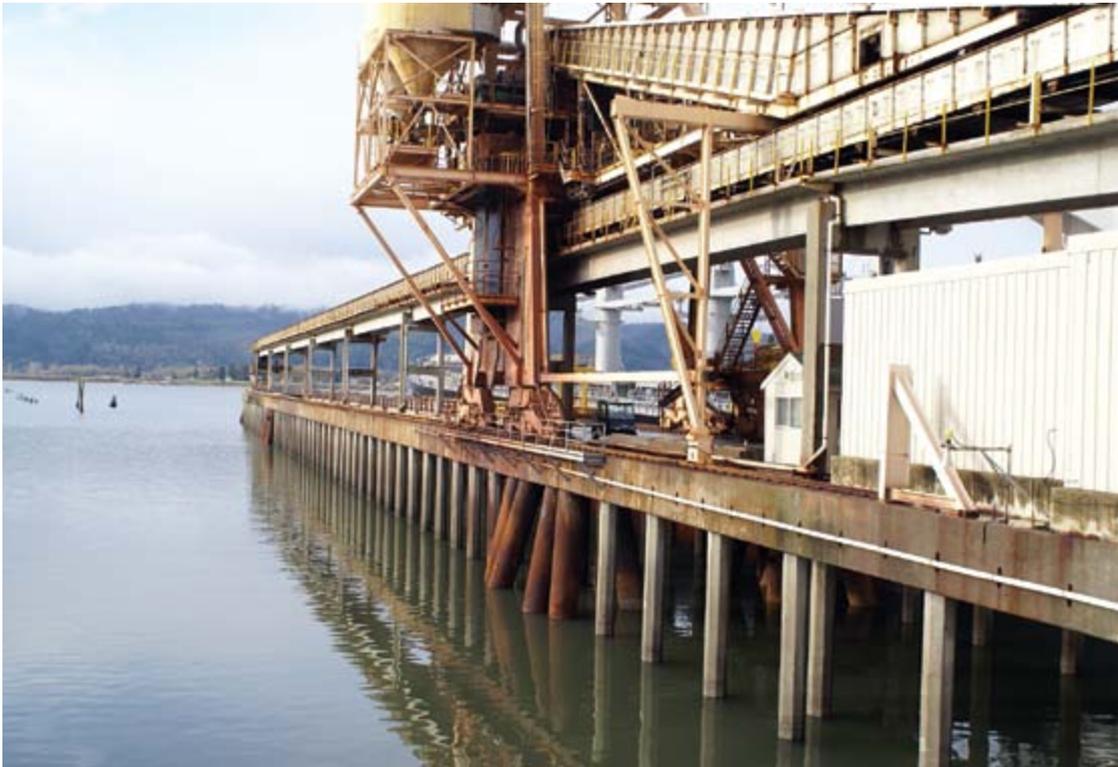
Project prior to repairs

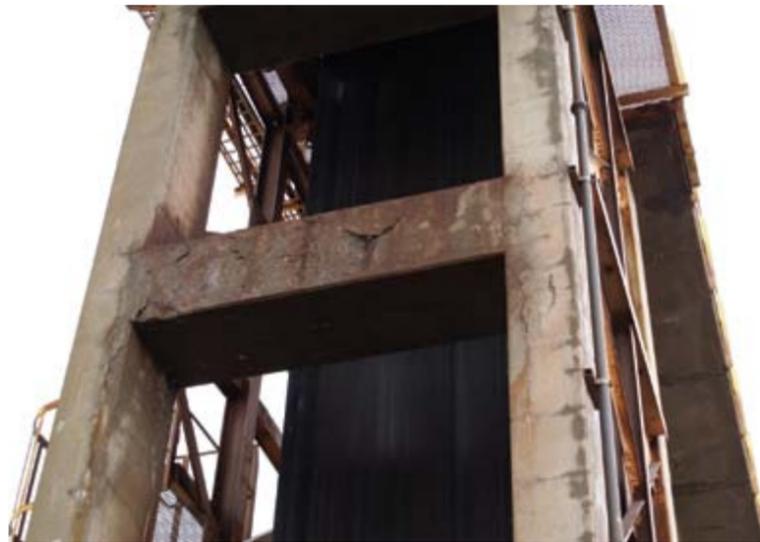
Deteriorated concrete at Port of Portland

Analysis of the existing concrete was also conducted to determine the level of sulfates and overall integrity of the host concrete. It was determined that the host concrete did have a high concentration of sulfates, so the approved, pre-packaged, engineered product had to show sulfate resistance—among many other qualifying project properties—to ensure a long-term successful repair.

The original quantities of concrete repair were estimated at 3247 ft³ (92 m³). It became apparent once the deteriorated concrete removal process had been executed that the extent of repairs required would be more far-reaching than first calculated. It became apparent that years of aggressive attack by sulfates from the overspill of previous conveyor raw materials led to more extensive deterioration of the concrete than originally estimated. The scope of the project had more than doubled from the original estimates for structural concrete repair, as listed previously, to a completed job total of 7290 ft³ (206 m³) of structural concrete repairs.

The scope of the project included, but was not limited to, the removal of the deteriorated and sulfate-contaminated concrete, exposing the full circumference of the reinforcing steel for proper surface preparation and splicing, as required by the contract documents. The project included concrete spall repairs caused by both noncorrosion and corrosion-related deterioration of the following concrete structures with the estimated quantities of repair per item:

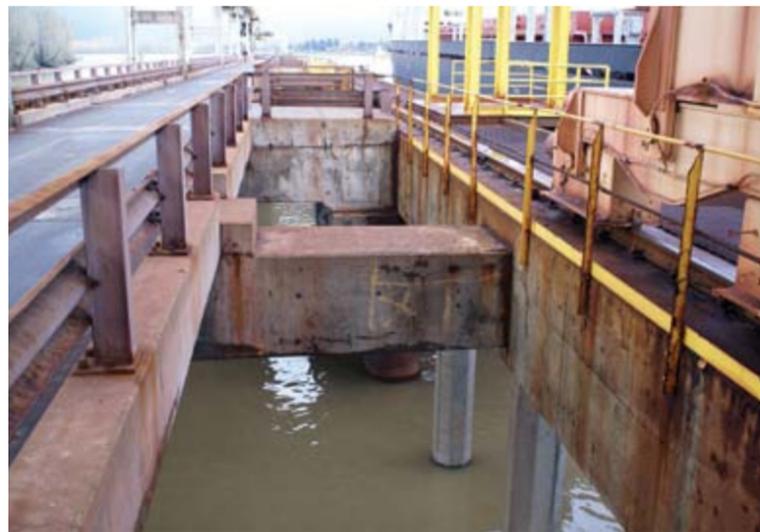
Deteriorated concrete on supporting pier

Over the years, it became visually apparent that concrete deterioration was active on the elevated concrete conveyor support system and supporting pier. The existing concrete was experiencing spalls and minor-to-severe stress cracks, with many of the stress cracks resulting in loss of structural integrity and reduced load-carrying capacity. The decrease in structural integrity, combined with the maximum elevated height of 49.85 ft (15.19 m) for the conveyor system, created the potential for falling concrete spalls. This became a safety concern due to the potential for injuries. Visual and sound method testing was conducted to estimate the extent of the repairs.

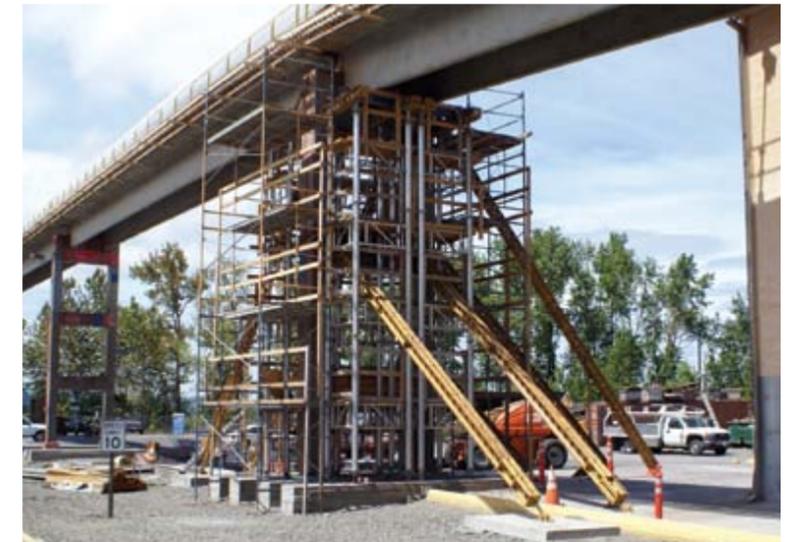
Extensive scaffolding was required on project

Extensive scaffolding was erected to provide safe access to perform the required concrete restoration on the elevated conveyor system and beam structure. Due to the severe deterioration and the resulting extent of concrete removal, an engineered shoring system was required to avoid any possible safety and operation issues.

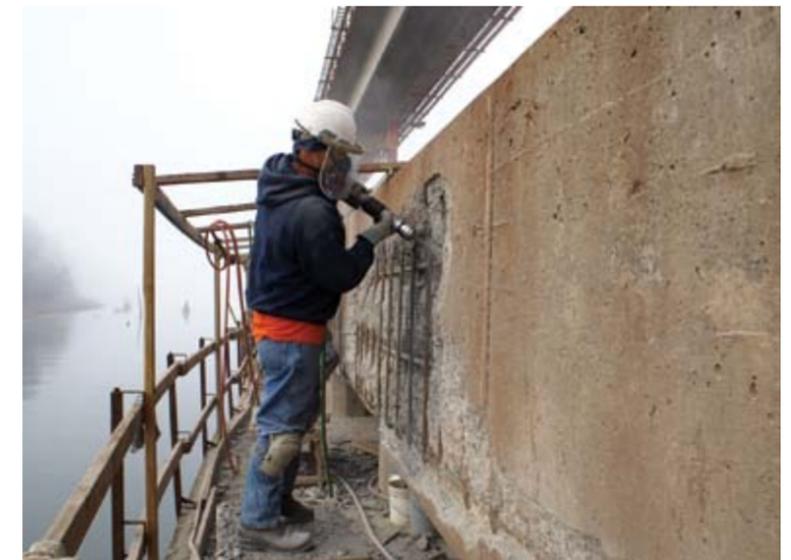
Removing deteriorated concrete

Pneumatic chipping hammers were used to remove the deteriorated concrete. The perimeter edge was then saw cut to a minimum of 2 in. (50 mm) in depth to ensure proper coverage and application. High-pressure water blasting was used to remove all loose concrete and concrete dust from the previous operations to help ensure a clean bond profile.

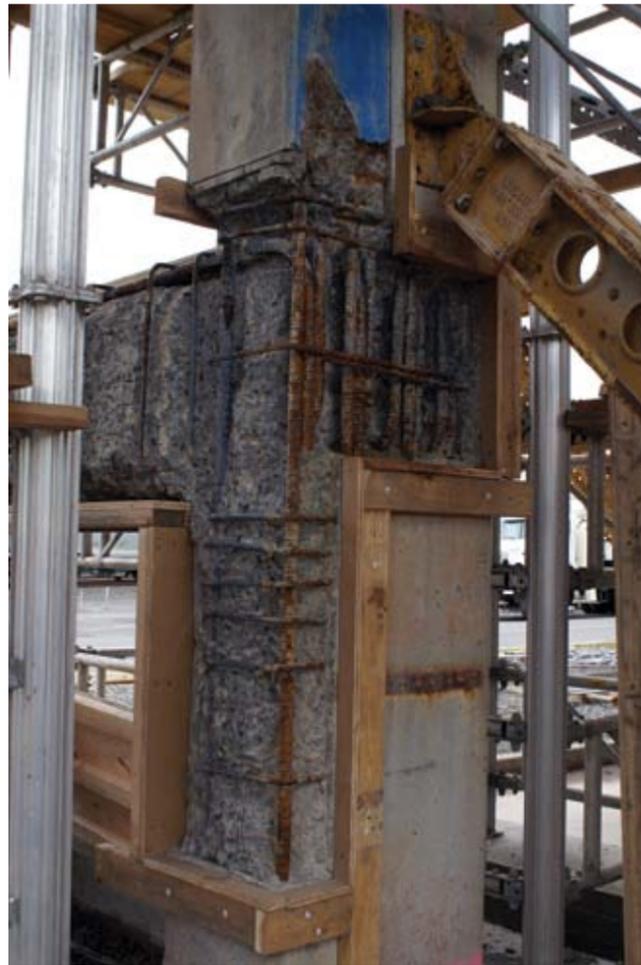
Framing in place ready for repair material

The reason for constructing the forming system using a wood frame, as required by the engineer, was to ensure a minimum embedment depth of 2 in. (50 mm) for the reinforcing steel.

In addition, this type of forming helped facilitate the application of the form-and-pump, self-consolidating, structural prepackaged repair mortar. The use of the wood framing allowed for ease of pumping of the prebagged repair mortar from the bottom up in a nonclosed application, which lowers the propensity to generate voids.

The repair zone was predampened for 24 hours prior to application by filling the watertight formed area overnight with water. After 24 hours, the face board was removed and the water was drained. An appropriate time was given for the surface water to evaporate, leaving the substrate in the proper saturated, surface-dry condition for bonding. The forms were coated with a water-

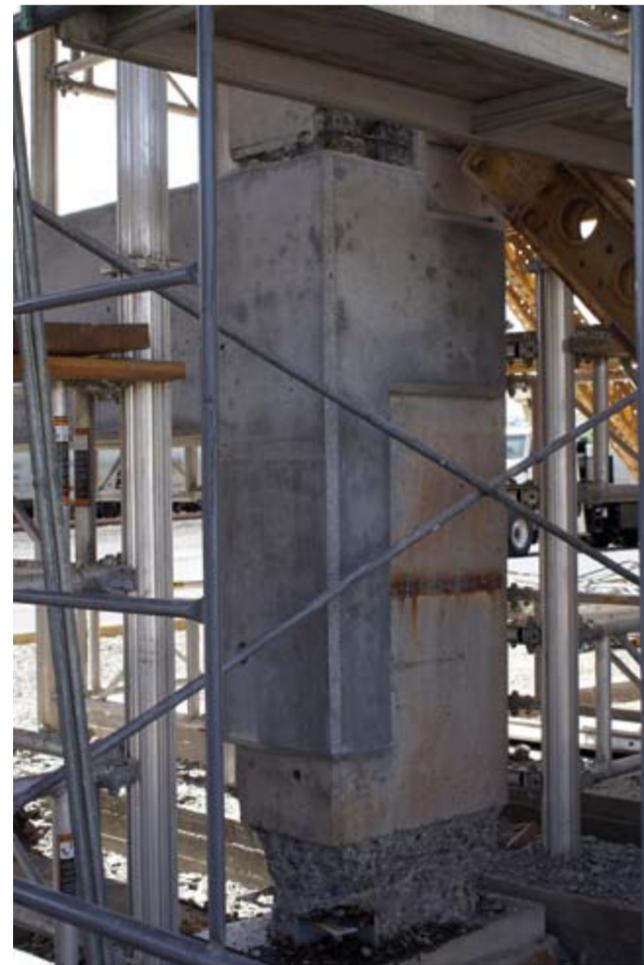
Column after repair

The product was mixed and installed using a mixer and pump combination. The product was mixed by a specialized mixer that uses an inline spiral mixer to properly combine the powder and water at the correct ratios on demand. As stated previously, this equipment allowed for the product to be mixed on demand, lowering overall project waste. The properly mixed product was delivered directly to the rotor-stator style pump for delivery to the preset, predampened forming system. The pump was able to deliver the product up to the top of the 50 ft (15.2 m) tower beams and legs without an issue. The two photographs above show the before and after of a typical type of concrete repair done on this project.

After placement, the forms were left on for a minimum of 7 days to allow for proper curing and strength gain. If the forms were removed prior to a 7-day cure time, then the application of an approved membrane-forming curing compound was specified. Compressive strength testing conducted prior to the commencement of the

project determined the necessary cure time to ensure structural soundness of the repair zone to avoid damaging the material during form removal. After the removal of the forms, the surfaces received an arc-spray zinc coating for protection. The top surface of the deck was coated with the preapproved waterproofing membrane, whereas the underside of the deck received the penetrating silane sealer.

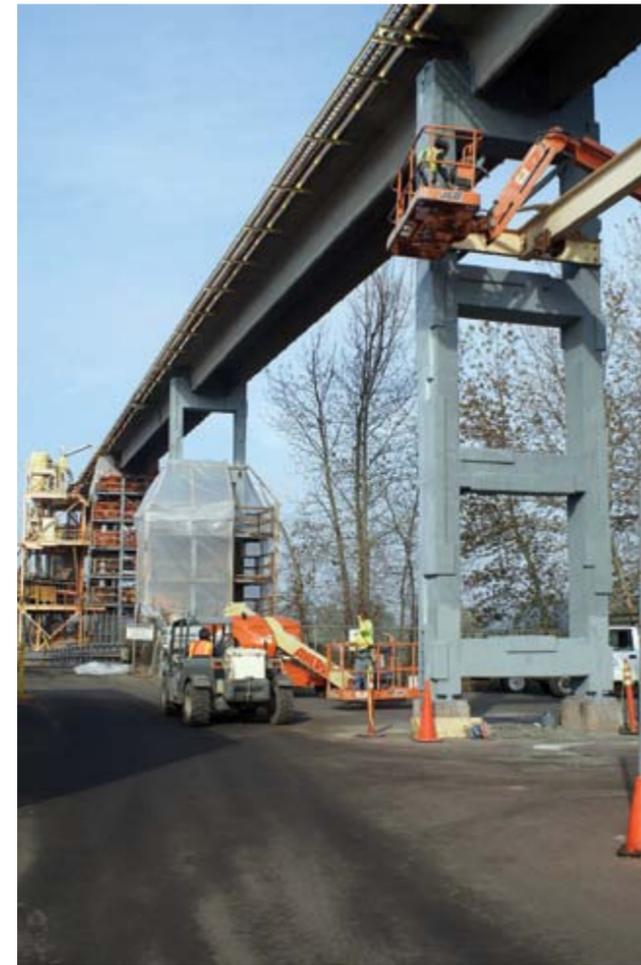
Project nearing completion

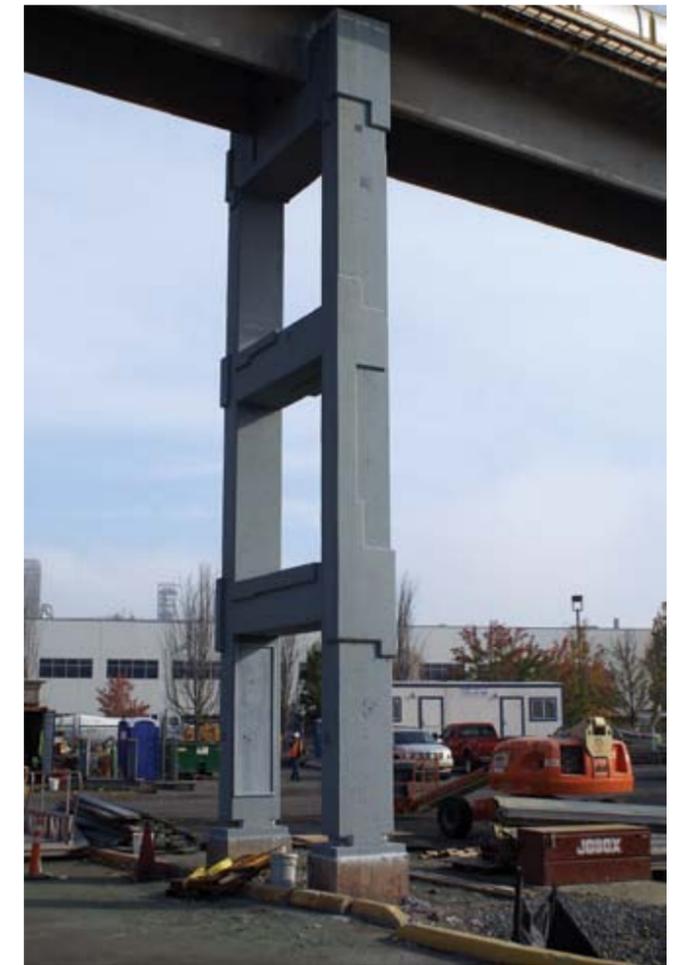
Finished project
